MEMORANDUM

To: Chief Doug Spears, City of Saginaw

From: Misty D. Christian, P.E.
Kimley-Horn and Associates, Inc.

Subject: Fire Station Drainage Assessment

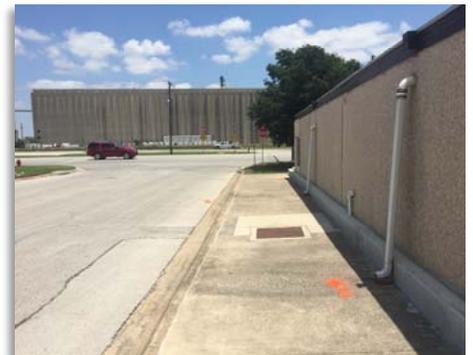
As mentioned in the section above, Bus. Hwy 287 floods during heavy storm events. In the past, the water from Bus. Hwy 287 has entered the fire station through the fire truck bays. However, more commonly, water enters the building through the north wall of the building which is located adjacent to Franklin Avenue. Water has overtopped the top of curb along Franklin Avenue during heavy storm events and has inundated the area between the building face and the curb which causes the water to enter the building. It was also noted that water also enters the building when the water is contained within the curb of Franklin Avenue especially after days of rain events.

North Building Wall of the Fire Station: Franklin Avenue

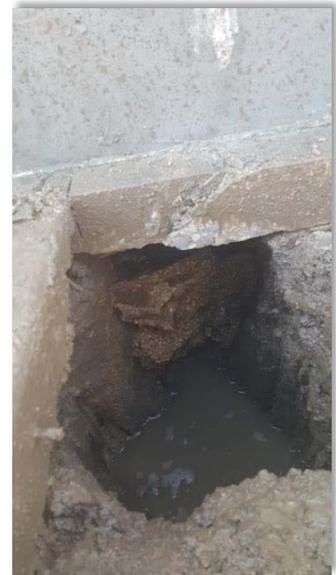
- The fire station wall did have an asphaltic/mastic material along the wall.
- There was a small void located in the area where water had been reported to infiltrate the wall.
- The soils were saturated with moisture.
- The wall was about 6-inches deeper than the at grade elevations.
- The living quarters of the fire station has a finished floor elevation lower than the top of curb elevation of Franklin Avenue

Void located under the building

Installation a French Drain System along the north wall would collect the ground water and convey it downstream. It is recommended the water is collected and sent to the sanitary sewer system which is located about 50 feet from the north building wall. Connecting the French Drain system to the storm drain system on Bus. Hwy 287 would not be feasible since the topography is higher at the highway than along the French Drain system. There would be costs associated with ‘treating’ the storm water as it connects to the sanitary sewer system. These costs would need to be added to the Opinion of Probable Construction Cost (OPCC) provided in **Appendix B**.

The benefit of installation the French Drain system is that it would alleviate some of the infiltration water. The water would be captured by the perforated pipe instead of entering through the wall. However, due to the nature of ground water, the French Drain system will not completely alleviate the flooding or infiltration. There is a chance that during heavy storm events, water will continue to enter the building since the finished floor is located below grade. This would be considered a solution to help the situation, but it will not solve the issue.

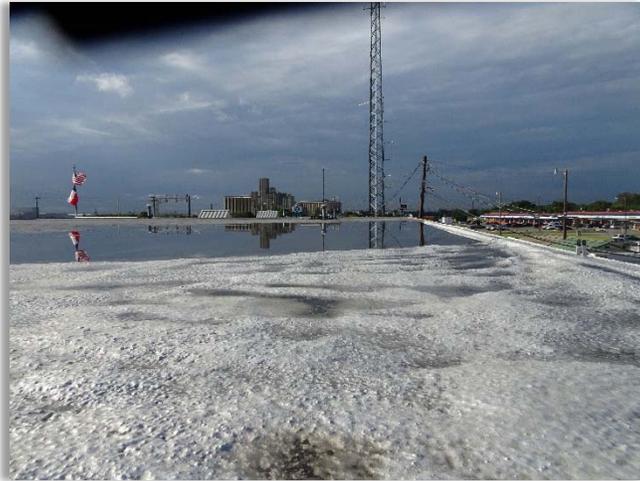
In addition to the observations at the north wall, Kimley-Horn observed other areas on the property that had poor drainage conditions. The roof system of the fire department did not have adequate drainage. The roof above the administrative offices was significantly holding water. Ponding of water occurred in the parking area to the west of the fire station. There were several indicators that the area around the fire station did not drain properly and the ponding water attributes to the saturated soil conditions.

Poor Drainage on the Building

Demolishing and reconstructing the living quarters within the same footprint of the existing facility would require the firemen to temporary relocate to other areas onsite while the construction occurred, but the need to relocate the sanitary sewer line, franchise utilities, and the generator would be avoided. The poor roof drainage could also be addressed with this option.

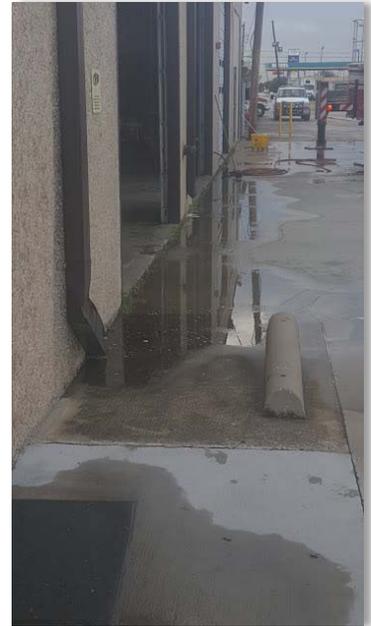
Poor Drainage along the Western Portion of the Building (Parking Area)

With both options, the new building could be expanded to accommodate the need for additional space. For both options, the 911 Call Center could also remain on-site without being affected. Site improvements could also be performed to improve the surface drainage on-site (parking area), however, since the fire station remains in a flood-prone area, the fire station will always be dealing with flooding issues along Bus. Hwy 287 or Franklin Avenue.
